August 8, 2013

Re: NOI, Baxter Road and Sconset Bluff Storm Damage Prevention Project

Submitted by: Robert S. Young, PhD, PG
Director, Program for the Study of Developed Shorelines

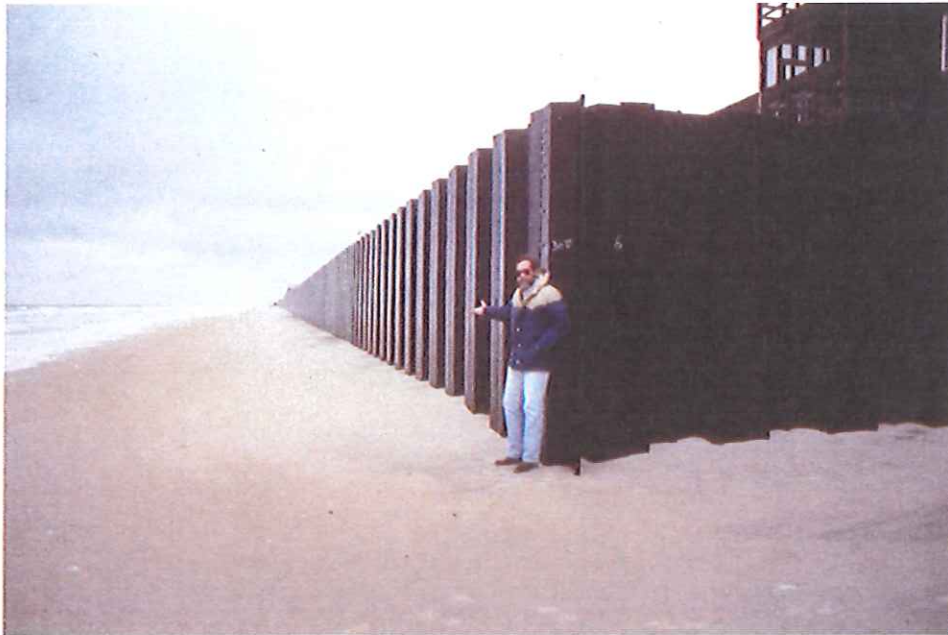
Fig. 1 Placement loss resulting from a seawall at Sandbridge, VA.

Hall and Pilkey (1991) point out that there are three types of erosion associated with a sea-walled beach: placement loss, passive erosion and active erosion. *Placement loss* occurs when a shore parallel structure is placed seaward of the dune, bluff, cliff or first line of vegetation, thus immediately reducing the width of the beach (Fig. 1). Rocks placed on the beach during the construction of any rock revetment such as that proposed for Sconset will result in an immediate loss of the upper portion of that beach. Thus, the project will likely result in immediate placement loss.

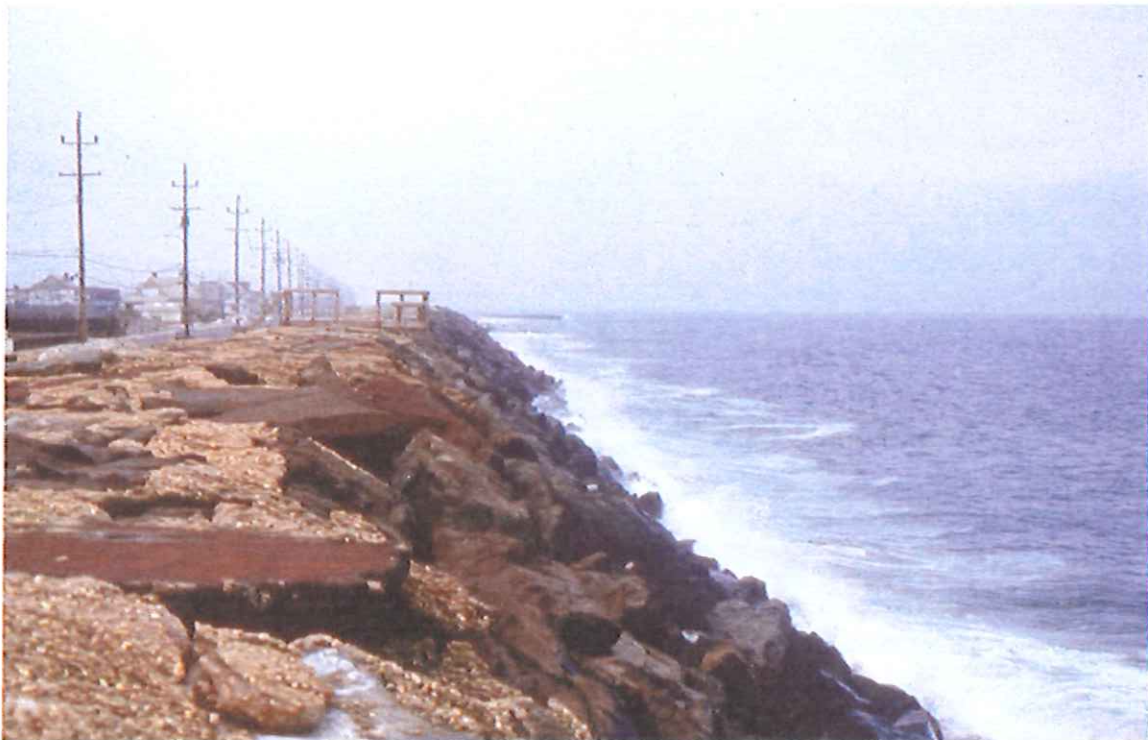
Fig. 2: Passive erosion at Sea Bright, NJ before beach nourishment.

Passive erosion occurs on an eroding or retreating beach when the dune line or upper beach is armored or replaced by a permanent hard stabilization structure, thereby causing the landward boundary of the beach to have a fixed location (Fig. 2-4). In effect, a “line in the sand has been drawn” beyond which the beach will not be allowed to naturally migrate. The problem is that building a seawall on a chronically retreating shoreline does not halt the erosion or shoreline movement. It simply creates a landward boundary for the ocean shoreline to run into. On an eroding shore (and the vast majority of the sand beaches in the US are eroding), the beach will simply narrow in front of the seawall until it disappears. It should be made very clear that on any sandy shoreline experiencing shoreline retreat, erosion does not destroy the beach. It simply moves the beach landward. However, placing an immovable object such as a large building or a seawall in the way of that retreat will remove the beach, and along with it, any public easement or access. It is this fundamental understanding of passive erosion’s effects on beaches that has caused many states to ban seawalls, revetments and bulkheads on ocean shorelines. Engineers typically do not consider passive erosion when planning for the protection of coastal property, assuming that the goal is to protect an investment, and not the beach. Once the beach (and therefore the public easement) is gone, the only way to restore it is through constant replacement of the sand through beach nourishment. This lesson has been

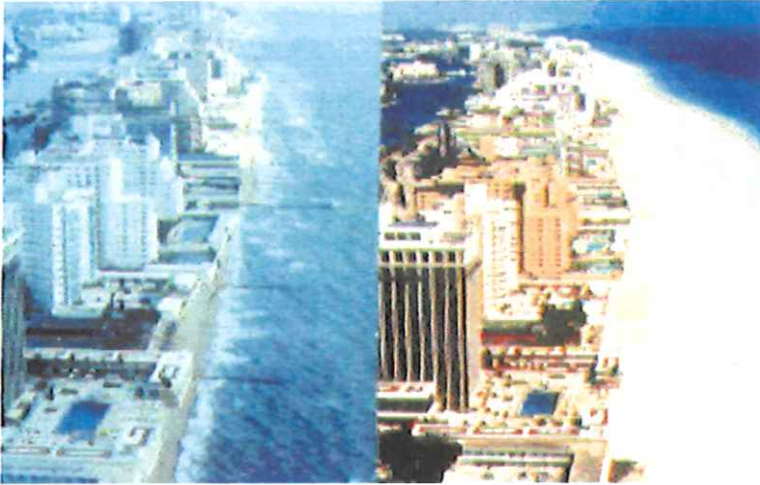
Fig 3: Miami Beach after years of passive erosion (left), and after massive beach renourishment.

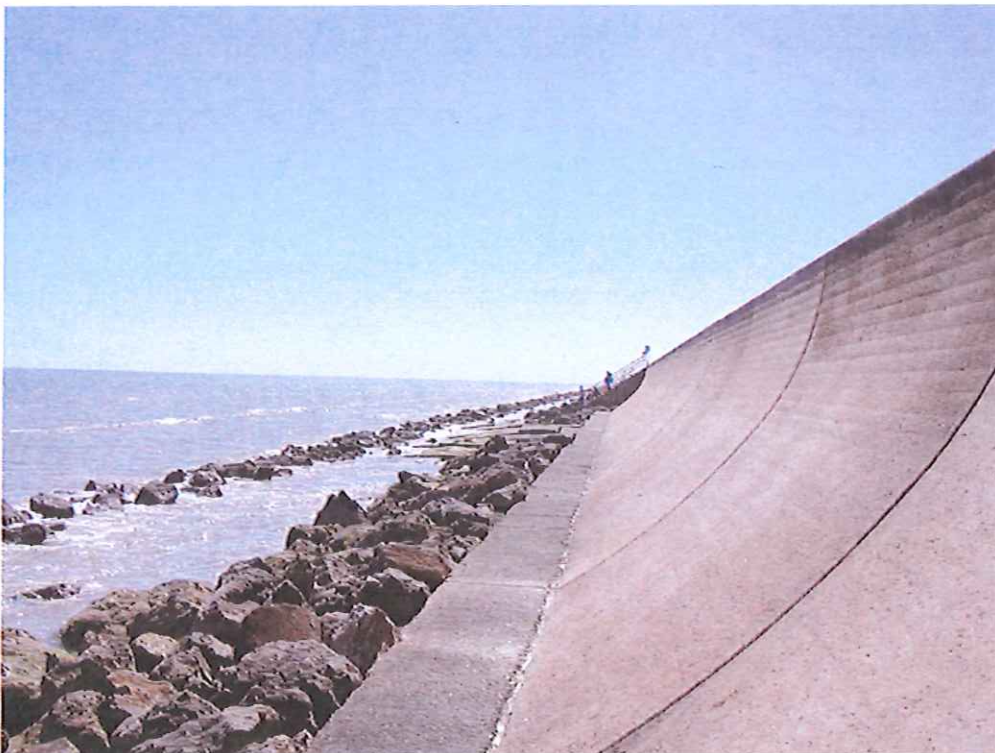
Fig. 4: Passive erosion at Galveston, TX

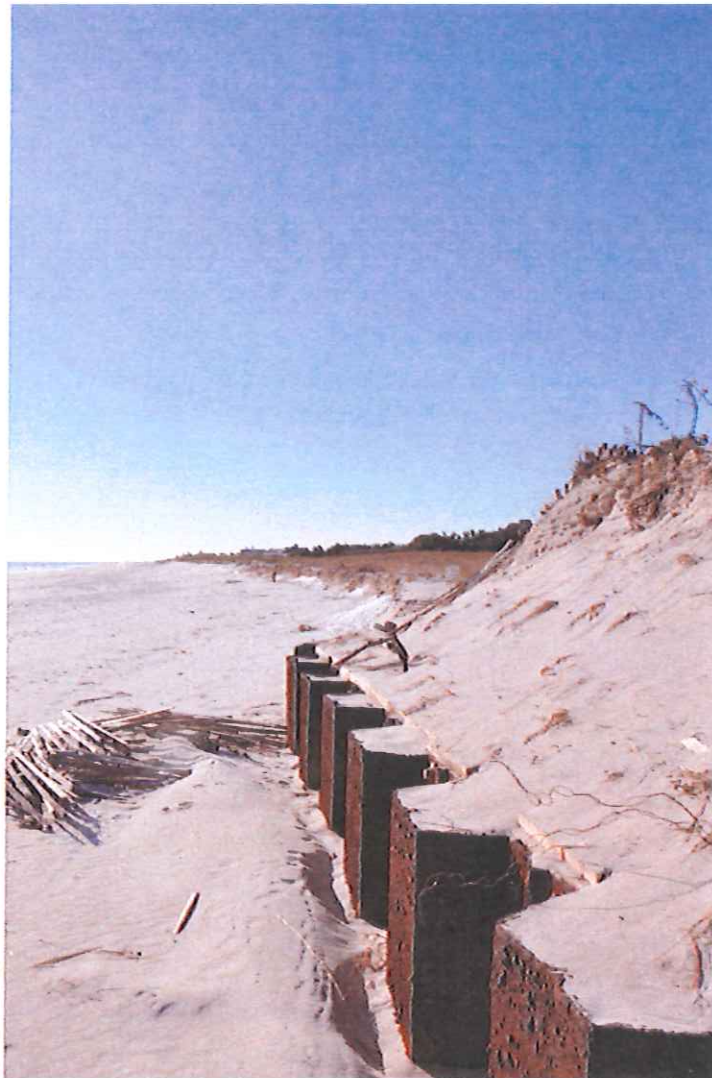
Fig. 5: End effect from a bulkhead, Southampton, NY

The end effect is the result of waves diffracting around the edges of the wall during storms or high water events. It results in a clear increase in erosion at the margins of the

seawall (Fig. 5). The end effect often results in the construction of another seawall on the adjacent property in order to protect it from the increased erosion. End effects have results in numerous neighbor-on-neighbor lawsuits on beaches around the US.
